April 15, 2014

Re: Forklift Barrier Test Report – Test #1
Cubic Designs Fabrication Facility
Waupaca, Wisconsin
PSI Project Number 0051845

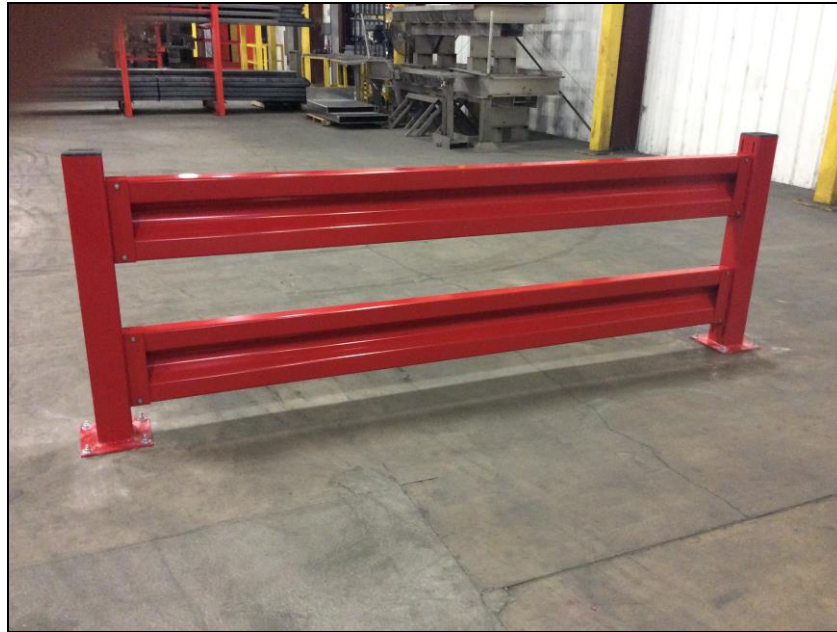
Testing was performed to verify that the barrier system would stop a forklift weighing at least 10,000 lbs traveling at a speed of 4 miles per hour (mph). The barrier system is shown in Photograph #1 and was comprised of following:

- Rail Material: 14 gage formed high strength steel, 50 ksi yield
- Rail Hanger: 11 gage high strength steel, 50 ksi yield
- Post: HSS5x5x7 gage, ASTM A500 Grade B, 46 ksi yield
- Base Plate: 10"x10"x3/8" plate, 50 ksi yield
- Anchors: (4)-1/2" dia. x 5" Powers Power Stud +SD1

Photo 1: Cubic Design Barrier System – Prior to Testing

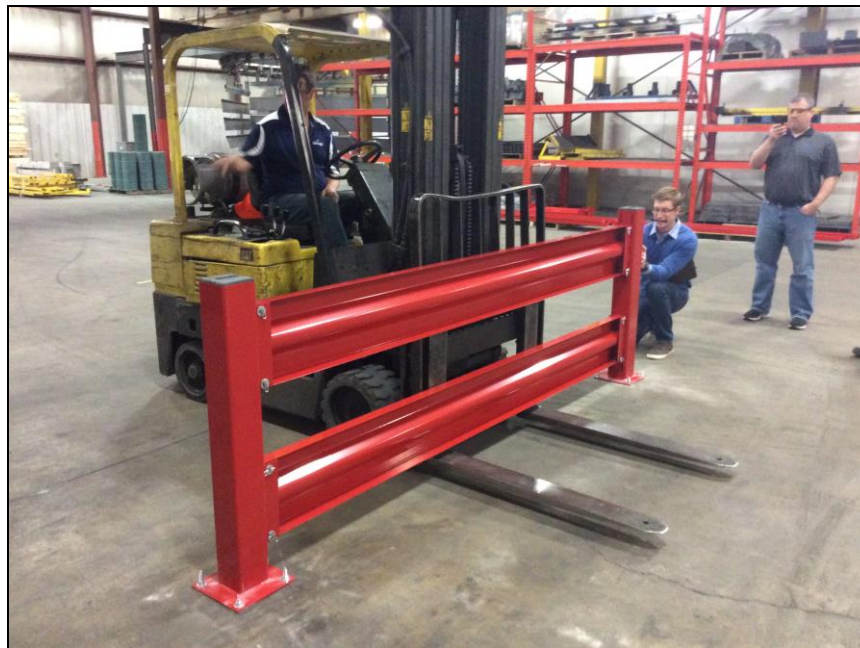
Prior to running the test, the forklift was aligned vertically with the barrier system so that the front of the forklift came in contact with both horizontal rail members of the barrier system. The forklift was also aligned horizontally with the barrier system so that the point of contact was centered on the horizontal rail members of the barrier system.

Photo 2: Alignment of the forklift with the system prior to testing.

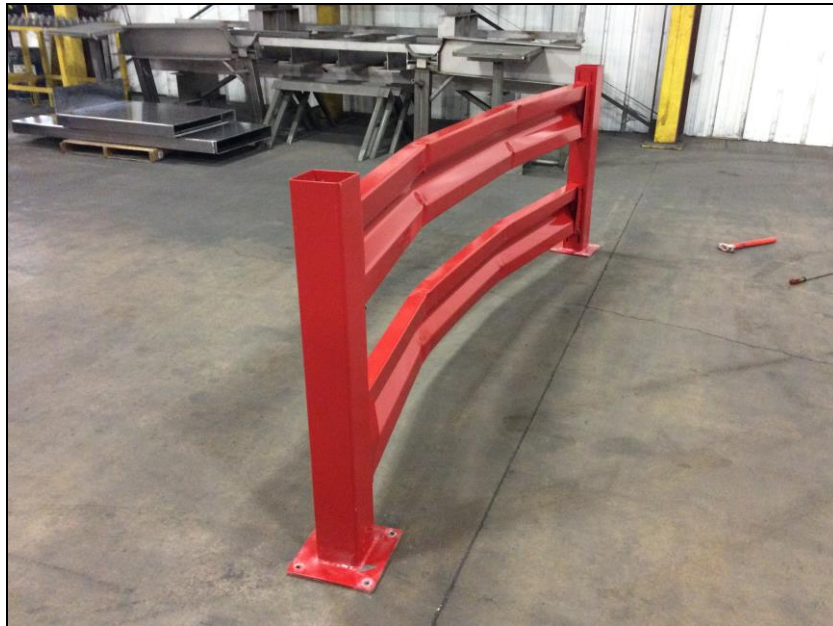
Upon striking the barrier system, the forklift caused a deflection of 6.0 inches to the top rail and 7.0 inches to the bottom rail. No visible failures were observed to the barrier system

Photo 3: Deflection in the system after testing.

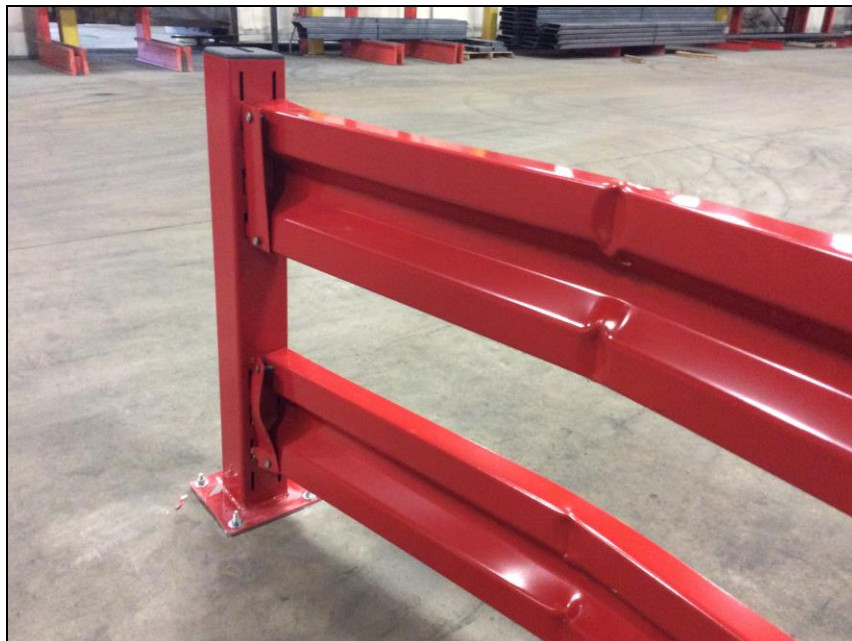
and the forklift was stopped, which met the testing criteria listed above. Photographs #4, #5 and #6 show the deflection of the barrier system after the test.

Photo 4: Left side damage to hangers.

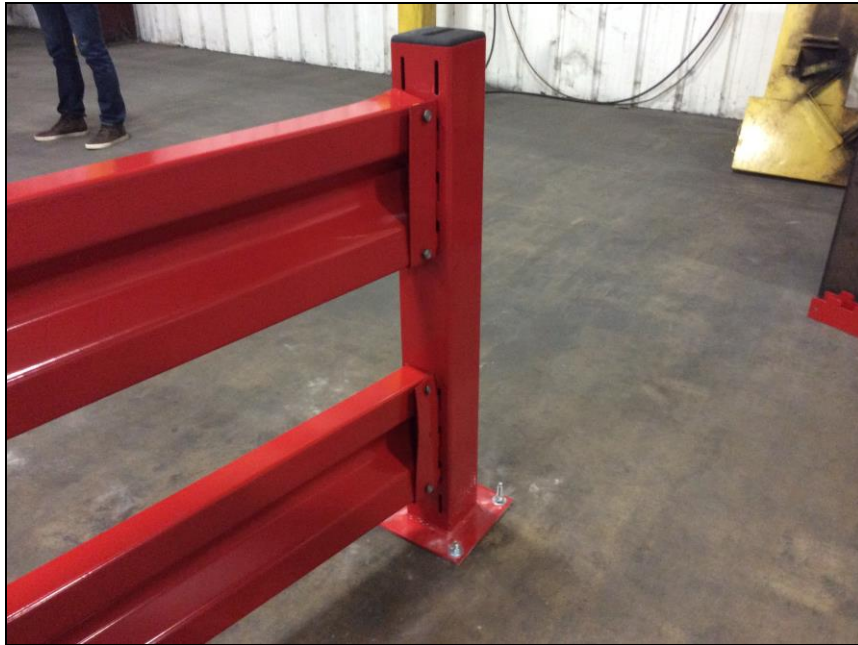
Photo 5: Right side damage to hangers.

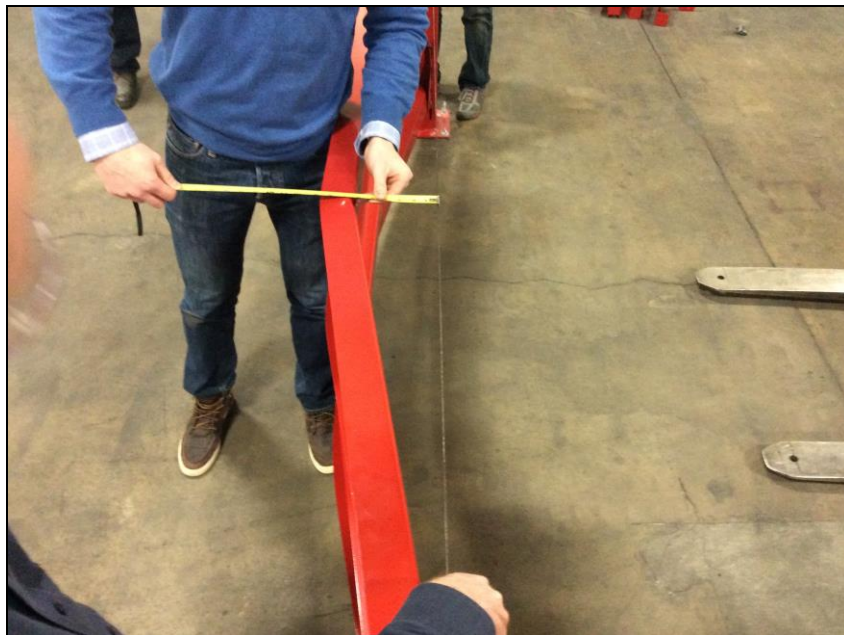
Photo 6: Measurement of deflection at most severe point.
